NAVAL AVIATION SAFETY CENTER
NAVAL AIR STATION
NORFOLK, VIRGINIA 23511

Subj: NARTU Alameda AAR ser 4-68A concerning A-4A BuNo 142160
accident occurring 14 January 1968, pilot COVILL

PART VI: DAMAGE TO THE AIRCRAFT

PART VII: THE INVESTIGATION

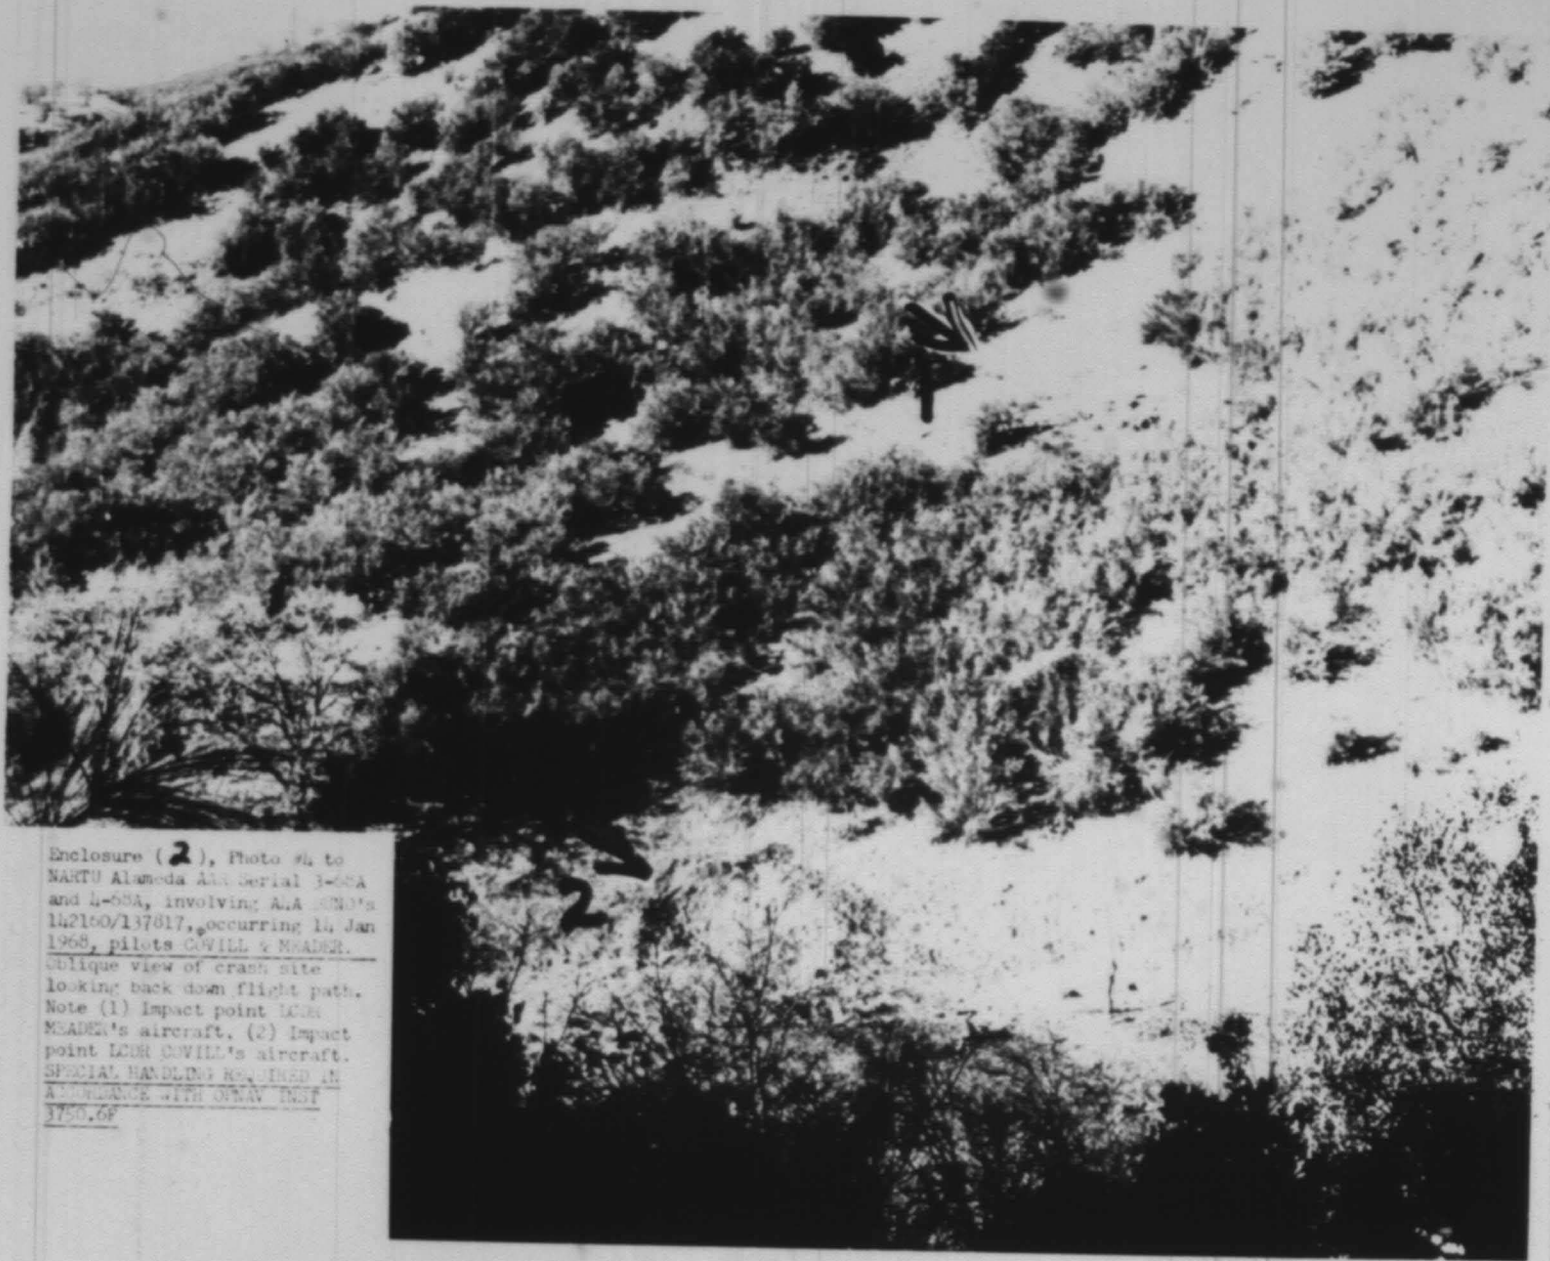
5. The impact craters of both aircraft and the wreckage distribution established the fact that the aircraft were in formation at the time of impact. LCDR COVILL in BUNO 142160 was leading the flight and LCDR MEADER in BUNO 137817 was in a step down left echelon position. LCDR COVILL's aircraft contacted the ground in a near wings level condition near a 25-30° nose down angle. LCDR MEADER's aircraft contacted the ground in a slight right wing down condition at near a 25-30° nose down angle. LCDR MEADER's aircraft appeared to have been in the process of moving in to a closer wing position at the time of impact.

Enclosure (2), Photo #4 to
 NARTU Alameda AFB Serial 3-65A
 and 4-65A, involving A1A BEND's
 142160/137817, occurring 14 Jan
 1968, pilots COWILL & MEADER.
 Oblique view of crash site
 looking back down flight path.
 Note (1) Impact point LCDR
 MEADER's aircraft, (2) Impact
 point LCDR COWILL's aircraft.
 SPECIAL HANDLING REQUIRED IN
 ACCORDANCE WITH ONYX INST
 3750.6F
